NASA Contractor Report 159261

VISUALIZATION OF IMPACT DAMAGE OF COMPOSITE
PLATES BY MEANS OF THE MOIRÉ TECHNIQUE

W. G. Knauss, C. D. Babcock,
and H. Chai

CALIFORNIA INSTITUTE OF TECHNOLOGY
Pasadena, California 91125

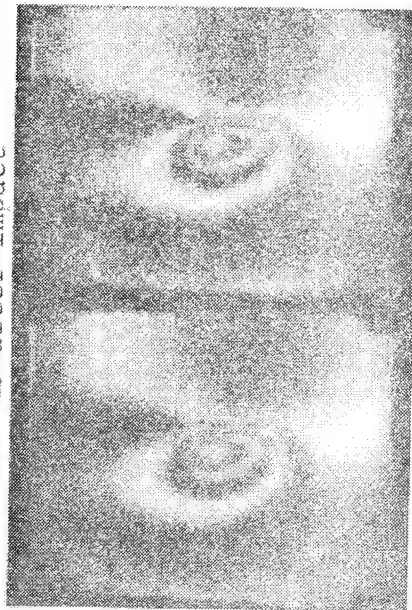
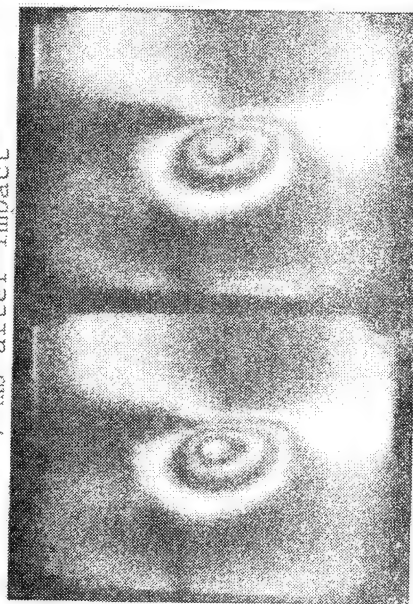
Fig. 13 Test Panel B-4, 21,000 frames/sec.

37 ms after impact

7 ms after impact

Fig. 13 Continued

The photographs for test panel B-4 are shown in fig. 13. The irregular dark pattern in this series of photographs is due to an optical interference. This panel was impacted at the same velocity as B-5 but was preloaded to a strain of 3180 $\mu\text{m}/\text{m}$. Catastrophic failure did not occur until approximately one minute after impact. The back surface permanent deformation was about 0.8 mm out of a total deformation of about 1.3 mm. Comparing this result to that of B-5 indicates some coupling of the in-plane load and the impact.

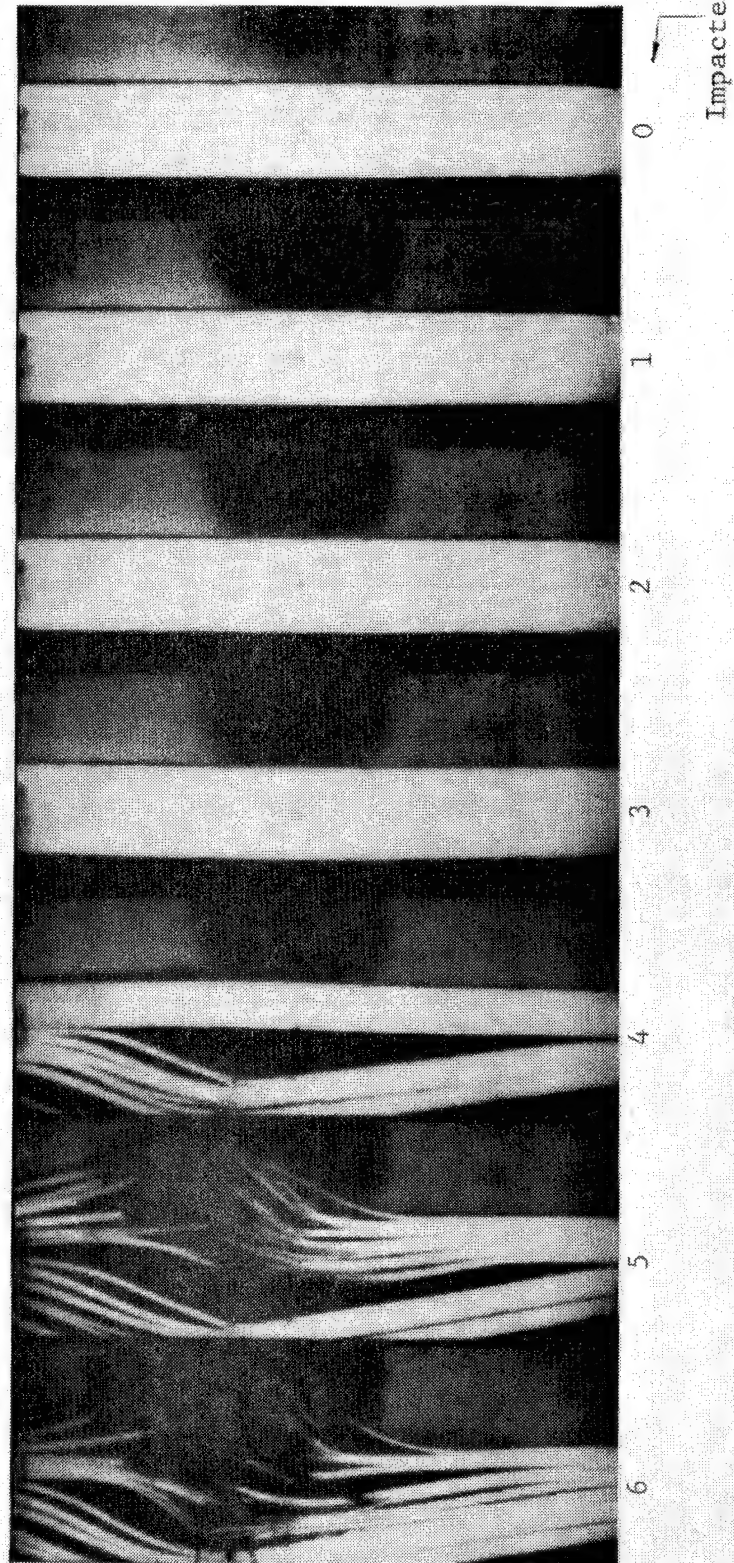
Fig. 14 Test Panel A-3, 15,500 frames/sec. (The portion of the test panel shown is free from support.)
